Research of the Barge Wreck in Careening Cove and it's role in 19th Century Charlotte Amalie Harbor Logistics

Research objective:

This research paper outlines the archaeological documentation of this barge wreckage in Careening Cove, Hassel Island, USVI. The main focus of this paper explores which company the barge belonged to and its historic uses.

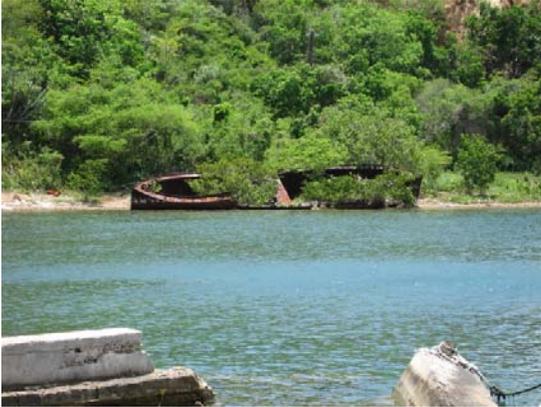
The wreck of the double-edged barge in Careening Cove is one of these neglected vessels. Its hull presently rests slightly on its side tilting toward the east. The barge's eastern side has collapsed, possibly due to the stranding, beaching, storm damage and rust that has weakened this side. It was not possible to determine the exact cause with certainty due to the time limitations during this initial survey effort. It was observed that a visible break of the eastern side slightly south of the midship balk was causing the hull to twist at least where the midship balk joins the western side of the barge⁶. In the northern end, the same is also noticeable, as the main stem/stern iron has broken about two meters from the top end⁷. It is also possible that the greater part of the lower hull, which is buried in sand and gravel and is half way below the water line, is gone. An excavation might be worth undertaking to determine the integrity of the lower part of the hull.

The Double-ended Barge seen from the East in May 2008.
Picture: Double ended Barge 020e.

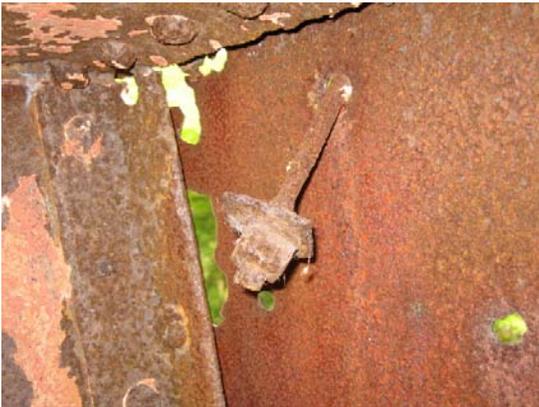
The general impression when examining this barge is that it has been built almost exclusively with rivets. However, it also features construction with nuts and bolts; the nuts being both with four and six sides (see pictures: Double-ended Barge 067e & 069e).

Picture: The Double-ended Barge 067e. (4 sided nut).

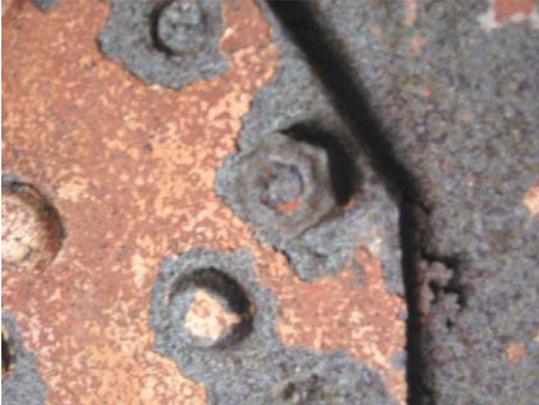
Picture: The Double-ended Barge 069e. (6 sided nut and rivet heads).

The nuts and bolts are primarily found in the upper part of the barge and it appears that they have been used primarily for attaching the fender wood on the outside part of the hull. It is unique that these nuts and bolts are not used entirely for attaching the fender wood. Ordinary rivets have also been used to attach wood. Rivets are used on some sections of the fender wood, generally amidships, while other sections have had the fender wood secured with nuts and bolts mainly toward the ends. The exact cause of these differences are unknown, but when compared with the bolted manhole on the north-western lower part of the barge, it is possible that there were repairs,¹¹ as it is generally the bow and the stern parts of a ship that often withstand unavoidable “blows” when docking. This would imply a greater need for repairs in these sections of a ship’s fender wood.

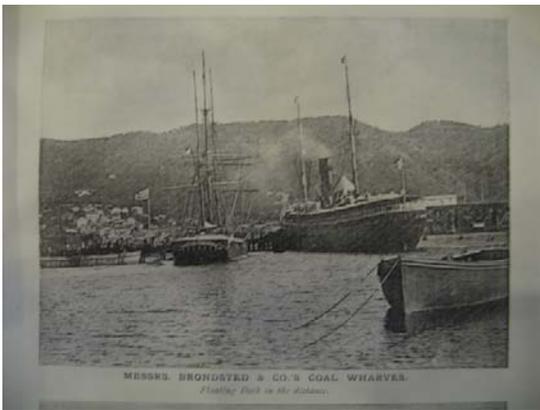
The first impression upon examining the stern and the bow of the barge is their similarities. Once more a thorough analysis of the different plate widths was completed. In so doing, it became apparent that there is however a difference, despite the similar construction details of both ends.²⁰ The southern end of the barge has proportions similar to the barge depicted in the picture of Brøndsted & Co Coal Wharf. The margin of error is approximately one percent, which is expected.²¹ The fender wood in the Brøndsted & Co Coal Wharf picture has a different appearance than the remaining fender wood on the Careening Cove barge as it lies today. This indicates that the remains of the Careening Cove barge is either a different barge altogether than the one in the picture, even though there are many similarities, or it is the same barge in the photograph but altered by later repairs. The latter conclusion appears more in agreement with earlier evidence to that effect.

Picture: Double-ended Barge Brøndsted & Co Coal Wharf e.

In both the stern and the bow segments, plating is riveted on to the main stern iron, compressing the stern iron between the side plating and the stem iron. Rivets pass through both plates. This construction approach further reinforces the argument regarding a skeleton construction technique. This construction must have necessitated a pre-bending of the side plates or heating of the side plates while riveting them to the stern/stem and the frames. Both techniques were common within the shipbuilding industry around 1900.²²

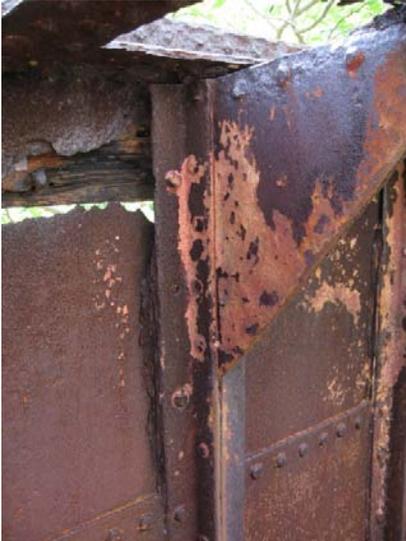
Among the barge wreckage, there are three holes purposely made either as repairs or from scavenging for plate material or bollards. In analyzing the two non-repaired holes,²⁴ it appears that a blowtorch or a similar instrument was used to make the holes. This is especially apparent in the photo (double-ended Barge 058e) where the edges look melted as opposed to being heated, chiselled and hammered out. Furthermore, the edges pictured in Photo 058 are not folded back, but rather follow the original plate's orientation thereby increasing the likelihood that the holes were cut with a blowtorch or similar kind of instrument. However, the deterioration and the rusted condition of the edges make it impossible to determine this conclusion for sure.

The reason why these two holes were formed is unclear, but the location of the hole in the walkway in photo 058 could indicate the removal of a bollard for use elsewhere after the barge had been abandoned, wrecked, or discarded. While the most logical explanation for the hole as depicted in the photo (double-ended Barge 025)²⁵, appears to be, that it was cut to get some spare plate for a purpose unrelated to the barge, as the edges again look melted, just like on photo (double-ended Barge 058e) and doesn't show signs of repair work being attempted.

Picture, Double-ended Barge 058e.

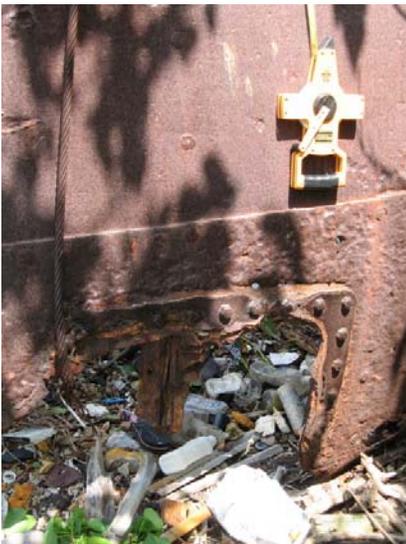
The third hole is different because it was covered with a metal plate that was bolted on to the side of the barge, indicating a repair while the barge was still in use. The use of bolts both here and on some parts of the fender wood could indicate a different shipwright or owner being involved in these repairs, but evidence for this will have to be strengthened with further analysis to be able to make a more accurate conclusion (Picture, Double-ended Barge 033e).

Picture, Double-ended Barge 033e.

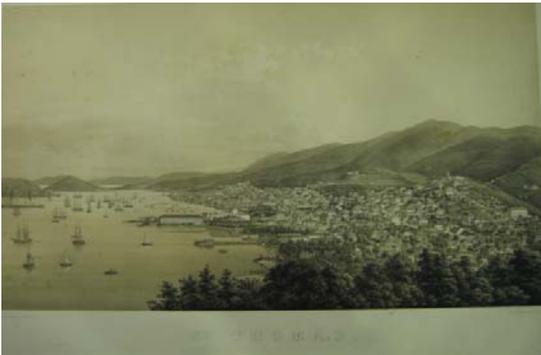
KB DWI, Picture 2625e. (est. to be from the 1860-1880).

Paintings and photographs that depict the harbor, like the drawing and photograph below, provide a general representation that corresponds extremely well with the written documents and the sea charts of St. Thomas harbor.⁵⁶ In examining the paintings and drawings it is clear that there are a lot of smaller vessels close to shore, just outside Charlotte Amalie's Kings Wharf. While the type of boat is not readily apparent, as they are sketched rather than properly drawn vessels, but the bigger vessels further out in the harbor are drawn with a greater attention to detail.⁵⁷

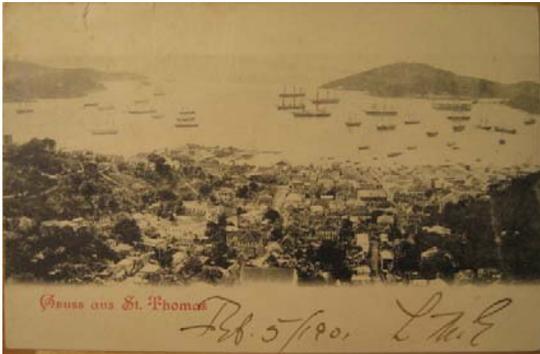
Picture: KB DWI, 3579e. (A postcard photo taken before 1901).

The placement of the depicted vessels in accordance to size corresponds well with the information provided in historic charts of the harbor. The accumulated evidence leads to the conclusion that this was the way that St. Thomas harbor operated from colonization through the nineteenth to the turn of the twentieth century. In sum, the larger vessels had to anchor in the deeper water of the harbor and from there loaded and offloaded their merchandise and cargoes to and from the barges and lighters that provided the only viable mode of transport between the deeper parts of the harbor and the warehouses in Charlotte Amalie.

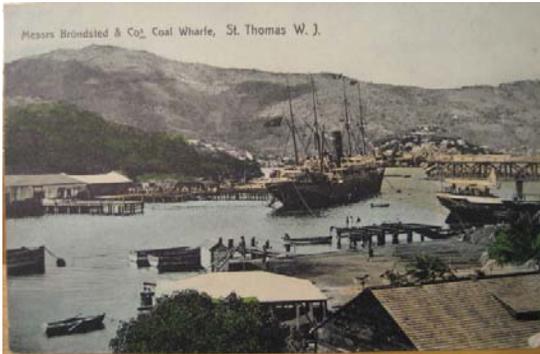
Picture: KB DWI, 3569e, seen from HAL coal depot towards the north, from before 1907.

Generally, the photographs and drawings of Careening Cove either depict the HAL side, the Brøndsted & Co facility, or both sides at the same time. In one image (KB DWI 3569), a steamer is alongside Brøndsted & Co's Coal Pier, but it is also apparent that another steamer rests alongside the HAL coal pier in the right side of the picture. A floating dock is in the background of the picture toward Charlotte Amalie.

Most interesting in this depiction are the three barges and lighters and the rowing boat lying in the lower left corner of the photograph. This is something that is observable in almost all of the pictures depicting steamers coaling. Almost no pictures or photographs show barges or lighters alongside steamers while coaling, except for a couple of photos, including one from the CGT wharf in Long Bay⁵⁹ and another showing a wharf with many rowing boats, barges of different types, and a small white steam boat.⁶⁰ This corroborates the conclusion drawn from the written sources that the standard procedure was to coal alongside a pier when coaling in St. Thomas harbor. However, it still does not exclude the possibility of coaling from a barge or a lighter. It also corresponds well with the evidence from the charts and the pictures that suggest that trading goods were delivered to and loaded from warehouses in Charlotte Amalie, while coaling was conducted on Hassel Island or Long Bay if the ship were from the CGT and possibly other affiliated companies.

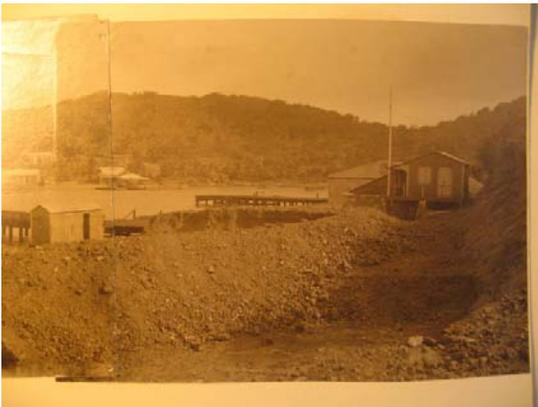
Picture: H&S 3498, HAL Wharf from 1900-1910, notice the white roofed buildings on the opposite (HAL) shore and the barge to the right in the Cove, comparable buildings are seen on the photo KD DWI 3606 on the cover page of this study. The barge on the right side of the Cove also bears a likeness to the barge on

There is a likeness of the buildings and barges in photos KB DWI 3606 and H&S 3498⁶¹,. KB DWI 3606 was found in an envelope with primarily pictures from around 1916, whereas H&S 3498 is dated to the period of 1900-1910, and depicts with certainty the HAL Wharf.

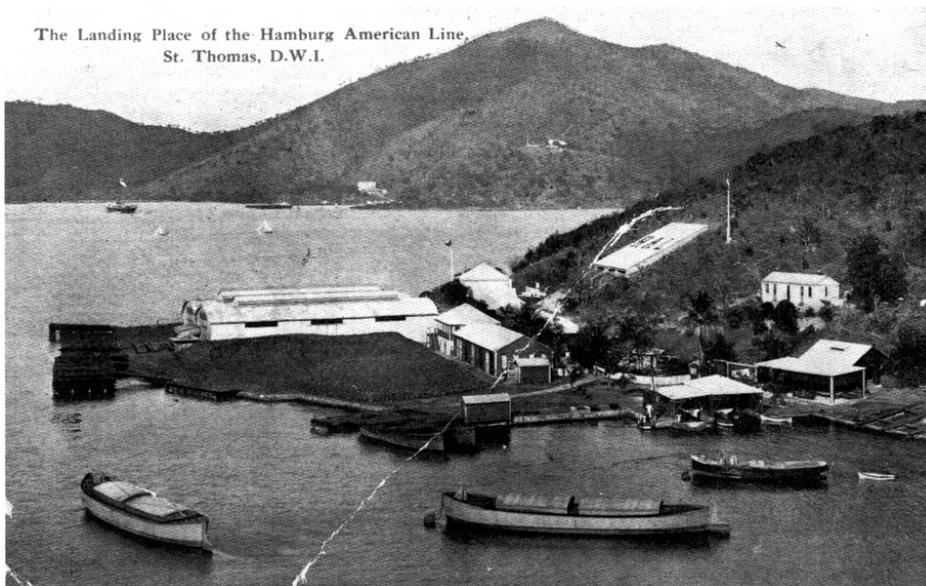
Further evidence to support this conclusion is the resemblance of the barge in the top right of the photograph, KB DWI 3606, to the two barges lying off HAL coaling pier in the photo below. These two larger barges (at left and center) and the smaller barge in KB DWI 3606 have sliding roofs over the holds, strongly indicating a similar origin since this is quite ingenious and a rare construction detail⁶³.

Double-Ended Barge, picture Kens final handover picture 013, from before 1917.

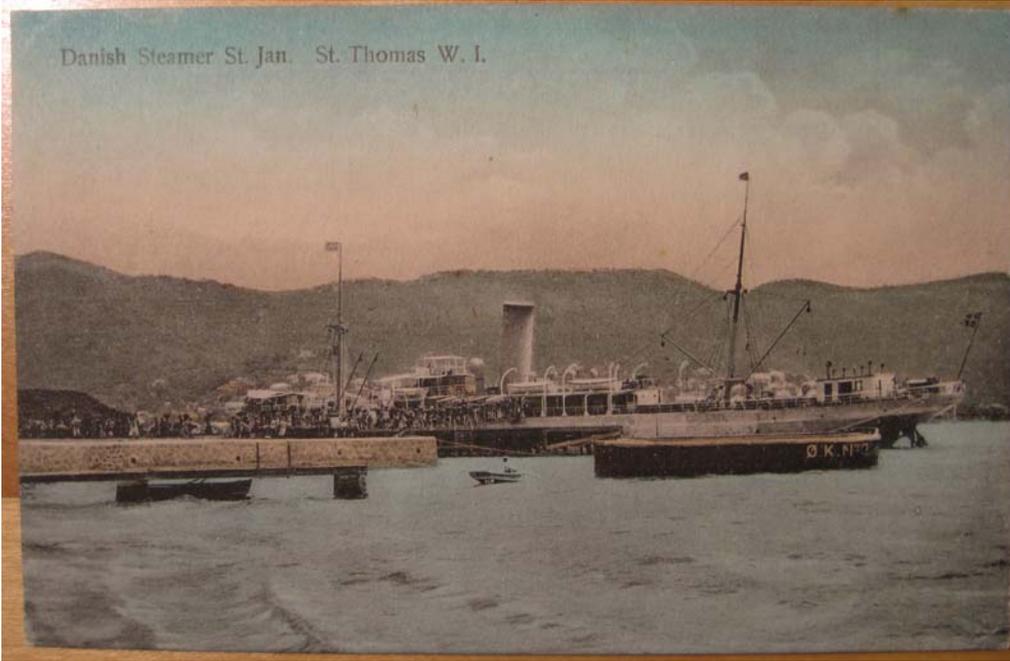
Picture: KB DWI 3596, showing barge with ØK No ... Name/Registration.

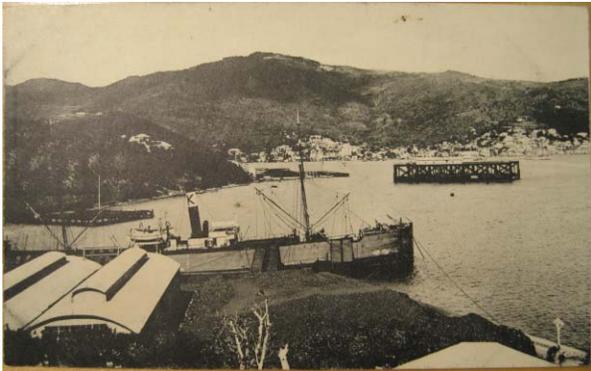
Picture, KB DWI 3588e, Showing a Steamer with a "K" funnel mark alongside the HAL Coal Pier.

A third photograph was selected because it depicts a ship's funnel mark with a large K on the steamer at the HAL coal pier. This K represents a ship from a different company than the pier's owner, since HAL's funnel mark was a tri-colored black, white, and red band.⁷³ This ship's K funnel mark thereby contradicts Gøbel's conclusion that the coal piers of HAL, RMSPC, EAC and CGT were exclusive. It is possible however; that this steamer with the K funnel mark was associated with an affiliated company. Further research can provide more insight into this.
