U.S. Department of the Interior NATIONAL PARK SERVICE Virgin Islands National Park

Various Tracts Caneel Bay Resort

Level I Pre-Acquisition Environmental Site Assessment Survey

September 4, 2012

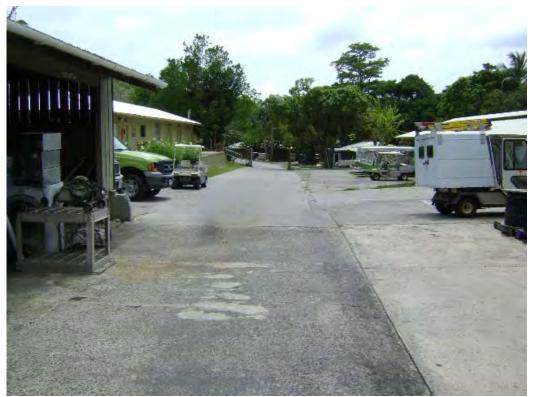
Engineering & Maintenance Area in Southeast Part of Subject Property

- Approximately 20 buildings are located in the engineering and maintenance area, which
  is in the southeast part of the property. The area appears to be used for the repair and
  maintenance of buildings, vehicles, golf carts, and landscape maintenance equipment,
  and for charging vehicular batteries. Numerous open and closed containers of waste
  motor oil, and oil filters were present in this area. Automotive batteries were observed
  on the concrete floors; the floors were stained from battery leakage. Several areas of oil
  stains on the work tables, concrete floors and on the soil outside the buildings were
  observed in this area. Numerous storm water drains are present near buildings with oil
  stained floors. The storm water drains and the surface drainage in the area appear to
  flow east and north to a small drainage ditch north of the engineering area. The stained
  tables, floors and soil are considered to be a recognized environmental condition (REC).

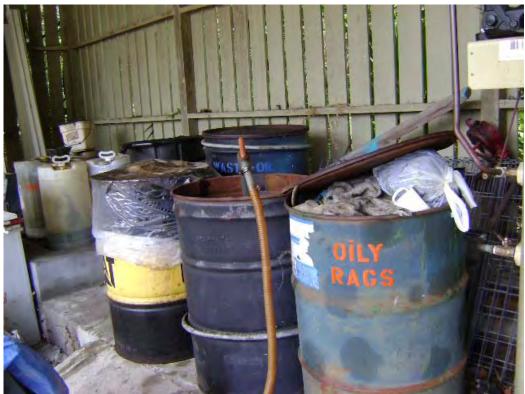
Waste Oil Storage Area in Engineering & Maintenance Area

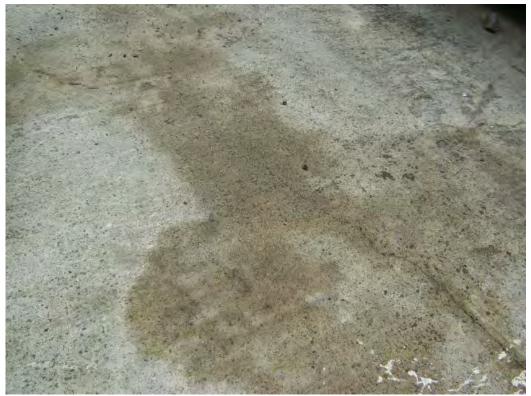
Oil Stained Concrete Floor in Engineering & Maintenance Area

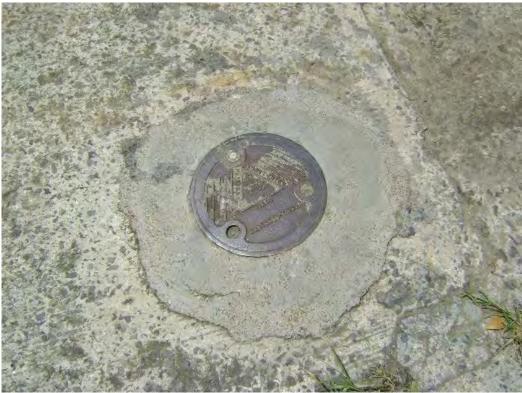
Monitoring Well in Pavement Near Diving Storage Building in Engineering & Maintenance Area

- A flush-mounted monitoring well manhole was observed in the concrete pavement just south of the diving storage building. Alvin Nazario with the Caneel Bay Resort indicated that the well was put in to monitor underground fuel storage tanks (USTs) that were removed from that area in the 1990s; Mr. Nazario stated that no contamination was detected in the well. The former USTs and monitoring well are considered to be a REC.

Correspondence with Alvin Nazario was accomplished via several emails in July and August of 2012. Specifically, Alvin was asked about the purpose of the monitoring well observed in the engineering area. He said that the well was installed in the 1990s when several fuel underground storage tanks (USTs) were removed from that area. He said that no groundwater contamination was detected in the well. He also said that he did not have a copy of the report on the removal of fuel contaminated soil a few years ago from the tank farm near the emergency generator building.

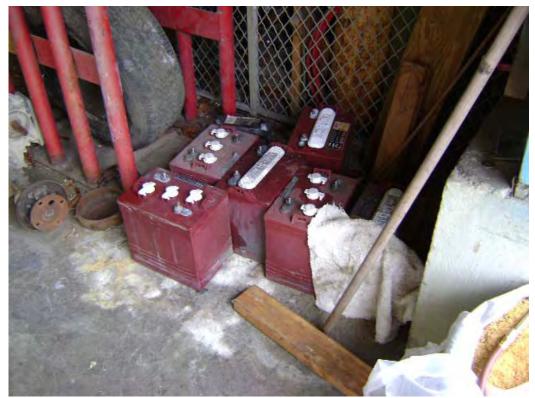
Automotive Batteries & Stained Concrete Floor in Engineering & Maintenance Area

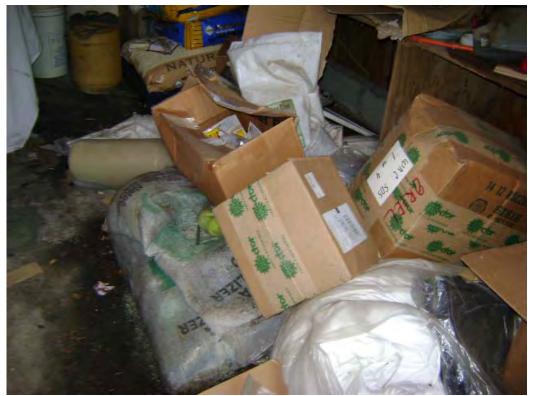
Fertilizer Spilled on Ground in Storage Shed in Grounds & Landscaping Area

- Approximately six buildings are located in this area, which is just west of engineering. The area appears to be used for growing plants, landscape equipment repairs, and storage of lawn and garden chemicals and supplies. Several storage buildings were observed with bags and containers of various pesticides, herbicides and fertilizers; these materials were observed to have leaked or spilled onto the unpaved floors of the sheds. These leaked or spilled materials are considered to be a REC.
- An open-sided equipment maintenance building was observed to have numerous pieces of oily equipment, oil stained tables, oil-stained concrete floors, an open container of used motor oil, and numerous cans of gasoline and oil. An oily odor was present in this area. The oil-stained tables and floors are considered to be a REC.

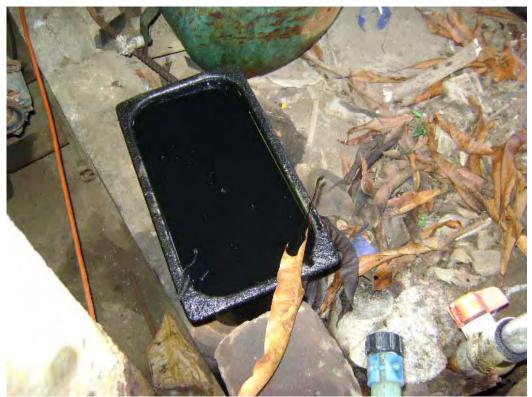
Open Container of Waste Oil in Building in Grounds & Landscaping Area

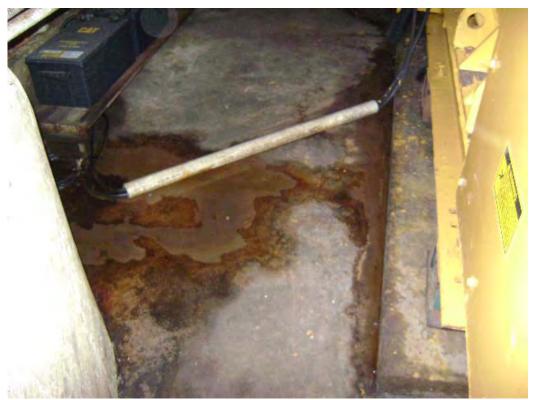
Oil & Batteries on Concrete Floor of Emergency Generator Building

This building is west of engineering and houses two large diesel-powered emergency electric generators. A strong oily odor was present in the building. The concrete floor beneath the generators was oil stained. Several large lead-acid batteries were present on the floor of the building. Two shallow floor gutters in the building appear to discharge oil or other liquid leaks from the generators to the soil outside on the east side of the building; two areas of oil-stained soil were present on the ground beneath these two discharge points. The oil-stained floors and soil are considered to be a REC.

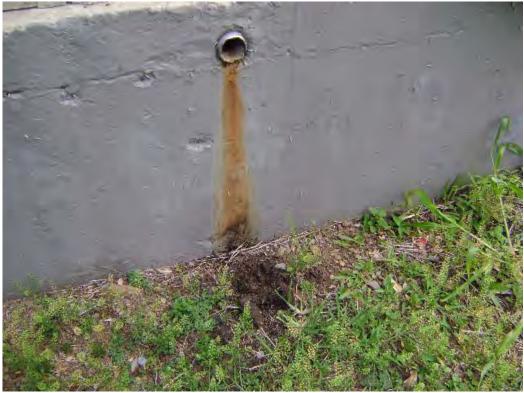
Oil Discharge From Floor of Emergency Generator Building to Soil Outside Building

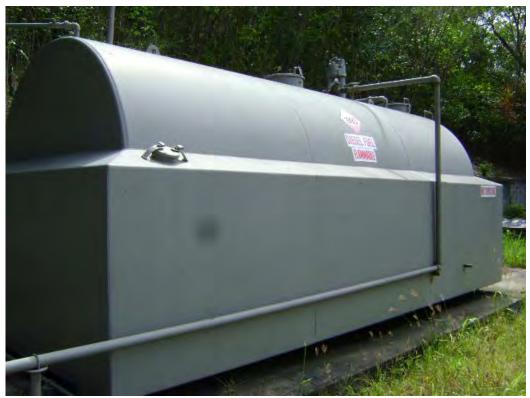
Above Ground Diesel Fuel Storage Tank for Emergency Generator

- Three above ground storage tanks (ASTs) are present just north of the generator building. One AST is approximately 20,000 gallons in capacity and appears to hold diesel fuel for the emergency generators. One AST is approximately 10,000 gallons and appears to hold gasoline. One AST is approximately 500 gallons and appears to hold gasoline. A diesel and gasoline fuel dispenser was present in the area. A diesel fuel leak is reported to have occurred two years ago; the fuel-impacted soil is reported to have been excavated, covered with a tarp and placed on a concrete pad near the ASTs. A covered area of stockpiled soil (approximately 15' by 40') was observed in this area; however, the exact area from which the soil was excavated was not determined.

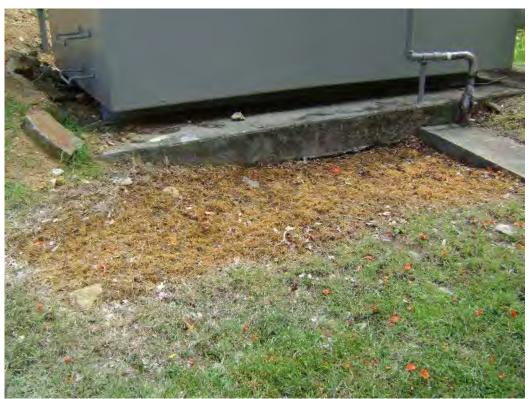
- An approximately 5' by 12' area of distressed vegetation and fuel-stained soil was observed just east of the 10,000-gallon gasoline AST; the leaked fuel appeared to be gasoline. The depth of the fuel-impacted soil was more than 6 inches.

Distressed Vegetation & Fuel Impacted Soil Near Gasoline Fuel Tank North of Generator Building

- The past and current fuel leaks and fuel-impacted soils in this area are considered to be RECs.

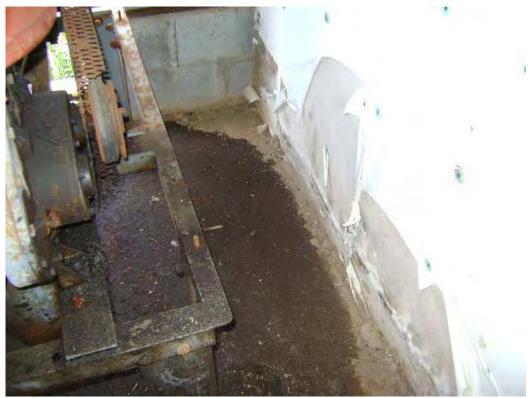
- An approximately 5' diameter oil stain was observed on the concrete floor of a small pump building for the plant.
- An approximately 2' diameter oil stain was observed on the ground near the treatment plant buildings. The stain appeared to be oil that leaked from a vehicle or other equipment previously parked at that location.
- The oil-stained floor and soil are considered to be RECs.

Oil Stained Floor Near Pump in Building at Wastewater Treatment Plant

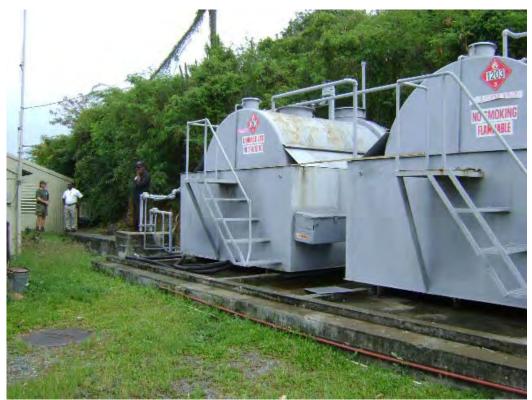
Above Ground Fuel Storage Tanks at Marina Facility

- The past and current operation of the marina, the fueling station, the fuel and waste oil ASTs, the fuel pipeline and boat repair facility (since the 1960s) are considered to be a REC for this tract.

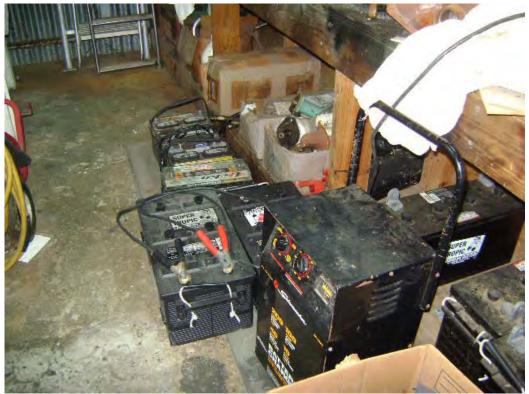
- Oil-stained concrete floors and an oily odor were present in the west building near open and closed containers of waste oil. Approximately ten lead-acid batteries were observed to be stored on the concrete floor; the floor near the batteries was stained. Numerous containers of paints, oils and cleaners were present in the west building. Outboard motors, fuel cans, air compressors and electric generators were also present in the building.

Batteries & Stains on Floor of West Building of Marina Facility

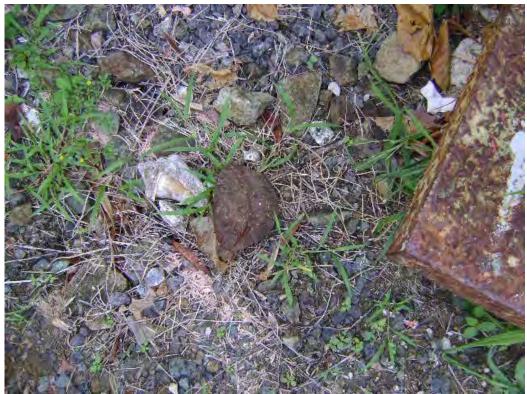
Polyurethane Resin on Ground at Marina Facility

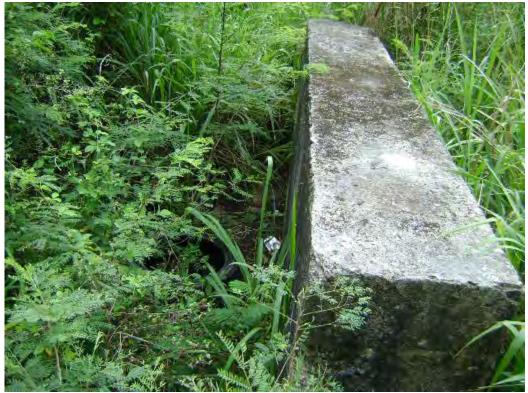
• The former location of the fuel ASTs is an overgrown area with two concrete tank support structures. No direct evidence of fuel spills or releases was observed in this area. However, the past operation of the fuel ASTs and underground pipeline is considered to be a REC for this tract.

Concrete Structure in Area of Former Above Ground Fuel Storage Tanks on Tract 04-104

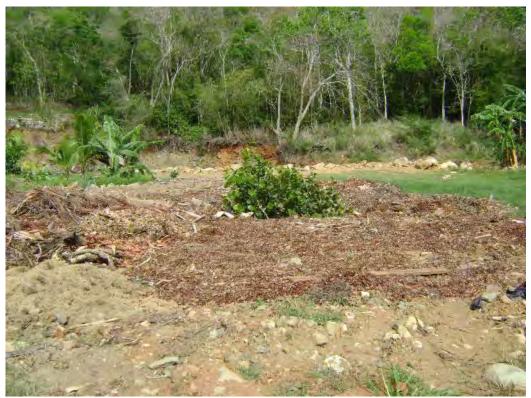
Debris Landfill Near Honeymoon Beach
